# **Final Report**

## **Missile Impact Resistance of Metal Mesh System**

**Florida Department of Community Affairs  
Division of Emergency Management  
Bureau of Preparedness and Response  
Critical Infrastructure and Logistics/Facilities**

August 2007

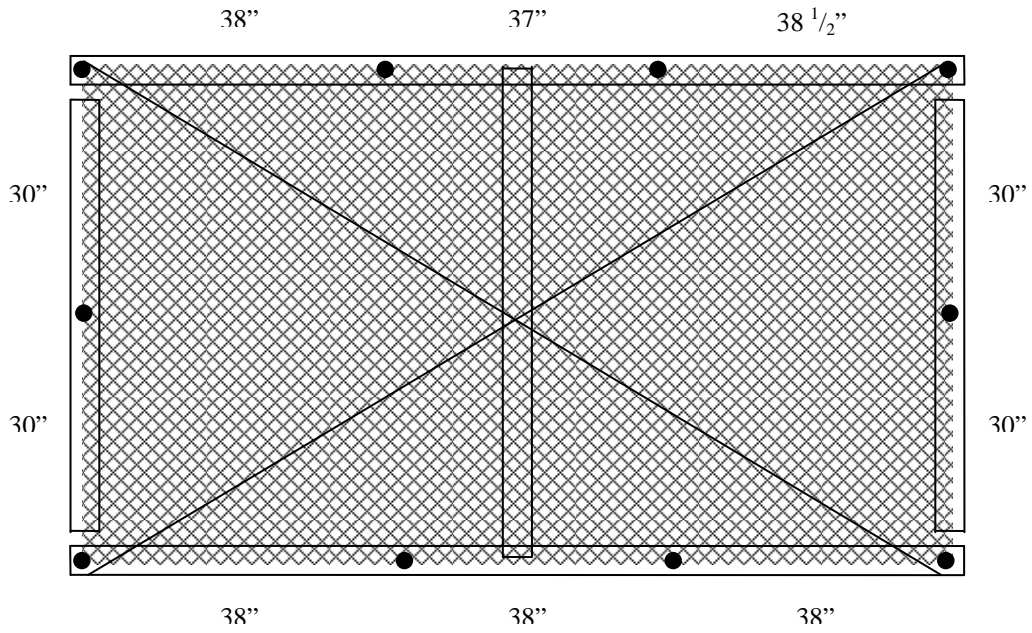
Figure 4 - Weld Spacing for Series 1 Tests on Frame 1

For the tests in Series 1, Frame 1 was impacted one time (Hit 1). This frame had a weld spacing of approximately 38 inches horizontally and 30 inches vertically (Figure 4). After the impact, results were documented.

Minimal, or no observable, damage occurred when the 2x4 struck at the required speed near the center of the specimen, away from the steel frame. An exception to this was for Hit 1 where the corner weld received the most damage. Note, however, that the weld spacing was 30 inches to 38 inches in the Hit 1 test; a much smaller weld spacing was used for subsequent tests. Considerable tearing occurred when the 2x4 struck near the center at an increased speed of 58 mph, as for Hit 10.

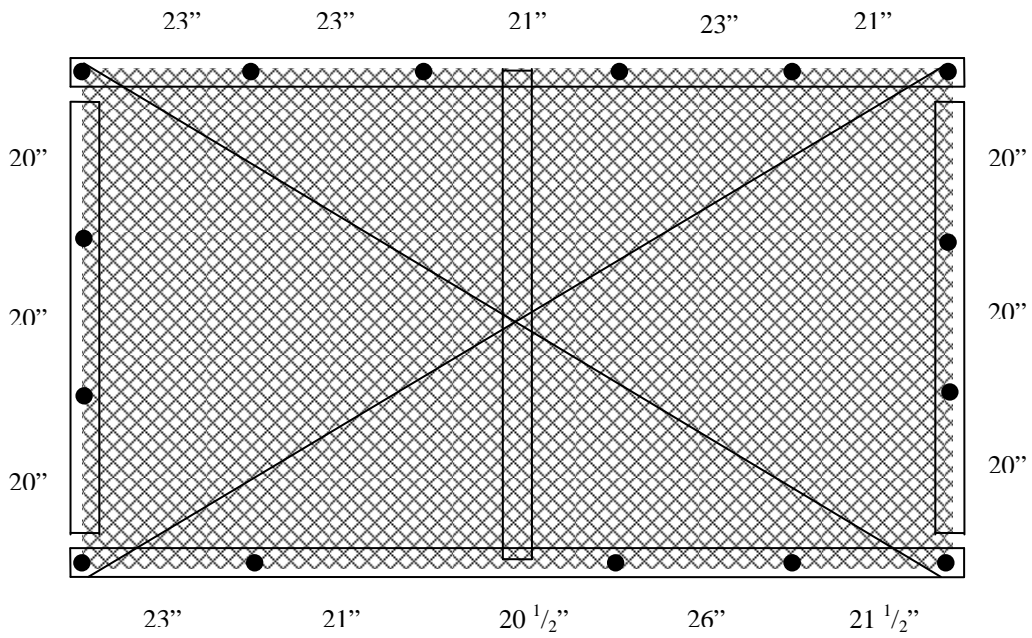
Figure 5 - Weld Spacing for Series 2 Tests on Frame 2

For the Series 2 tests, Frame 2 was impacted two times (Hits 2 and 3). This frame had a weld spacing of approximately 23 inches horizontally and 20 inches vertically (Figure 5). The frame was modified for Hit 3 by removing the center L3x3x3/16 brace. After each impact, results were documented.

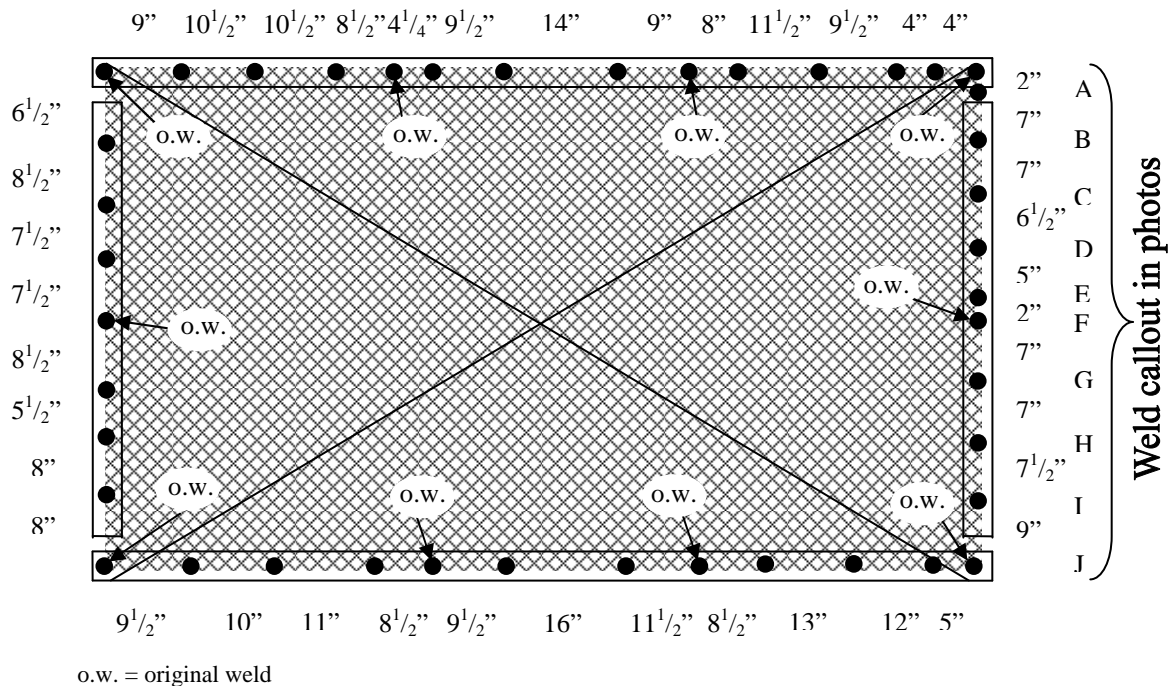
Figure 6 - Weld Spacing for Series 3 Tests on Frame 1

For the tests in Series 3, Frame 1 was impacted eight times (Hits 4 through 11). The weld spacings in Series 2 and 3 were large and resulted in local failure of the mesh material near the welds. Therefore, additional welds were added in the field to this frame, for a weld spacing of approximately 4 to 9 inches horizontally and 6 to 8 inches vertically (Figure 6). Also, for all hits

The metal mesh resisted penetration of the 2x4 in all cases that were tested. A comparison of Series 1, 2 and 3 tests shows that the behavior of the system is mainly a function of the weld spacing. A maximum weld spacing of 7 inches around the perimeter, with each weld being at least 1 inch long, produced the best test results. Although not specifically tested in this project, the presence of the 5/8 inch all-thread rods in the corners may not be insignificant. They may have helped resist additional tearing of the metal mesh when the 2x4 struck near the corner of the test frame.

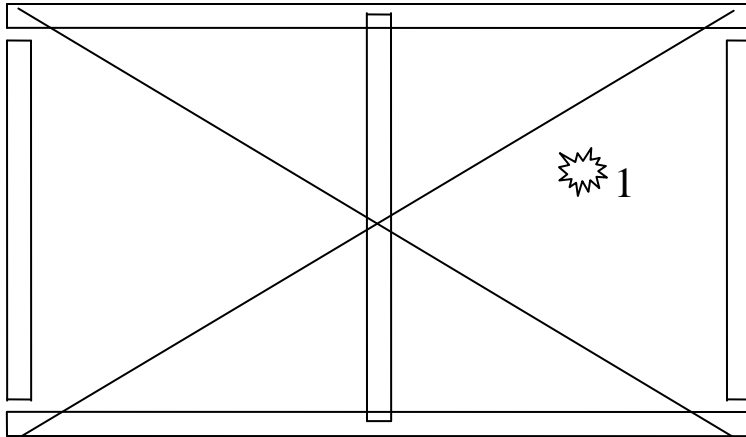
Figure 7 - Series 1 Tests Impact Locations (Hit 1)

Series	Hit	Missile Speed (mph)	Impact Location			Comments
			Horizontal	Vertical	Relative to:	
1 (Frame 1)	1	37	26"	20"	Top right	Mesh broke at top right corner weld.
2 (Frame 2)	2	36	25 ½"	27"	Top right	Mesh broke at 4 welds (1 at top right corner; 1 to left of and 2 below top right corner).
	3	36	8"	10 ½"	Top right	Mesh deformed at impact location.
3 (Frame 1)	4	36	29"	33 ½"	Top left	No observable damage.
	5	**	4"	11"	Top left	Mesh deformed at impact location; mesh broke near one weld.
	6	**	8"	8"	Top left	More deformation at impact location; mesh broke at top left corner.
	7	35	13 ½"	4"	Top right	Impacted steel frame. No observable damage.
	8	37	8"	15"	Top right	Mesh tore at impact location. Some damage near Weld C. 2x4 did not penetrate.
	9	37	7 ½"	24 ½"	Top right	No more observable damage to area of impact. Some damage near Weld D.
	10*	58*	57"	24"	Top right	Mesh tore at impact location and beyond.

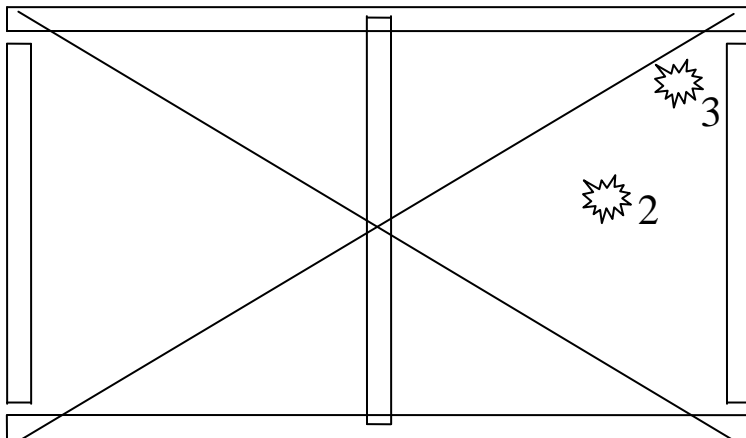
Figure 8 - Series 2 Tests Impact Locations (Hits 2 and 3)

Some deformation of the mesh was observed, such as in Hits 3, 5, and 6 where the 2x4 struck near the test frame steel members that supported the mesh. From all of the tests, the most notable damage occurred when the 2x4 struck near the test frame; damage was typically to the mesh in the region directly adjacent to the welds, where the mesh was often broken. Photos taken of the damage after impact are provided in Appendix A. Additional photos, taken after all testing was completed, are in Appendix B.

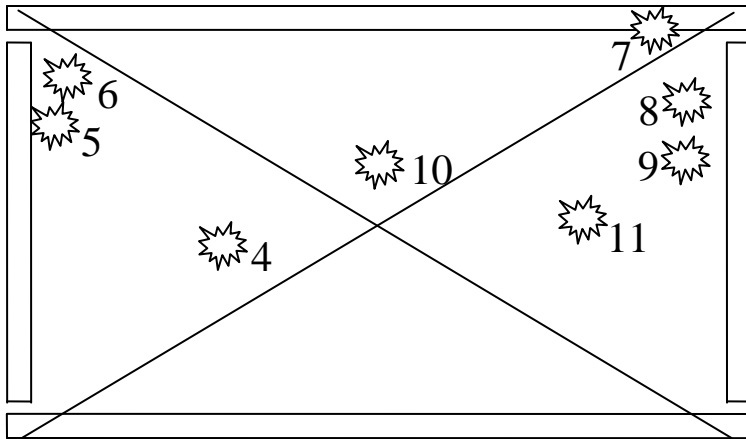
Figure 9 - Series 3 Tests Impact Locations (Hits 4 through 11)

11	**	28"	33"	Top right	No observable damage.
