CHAPTER 3

TEST PROGRAM

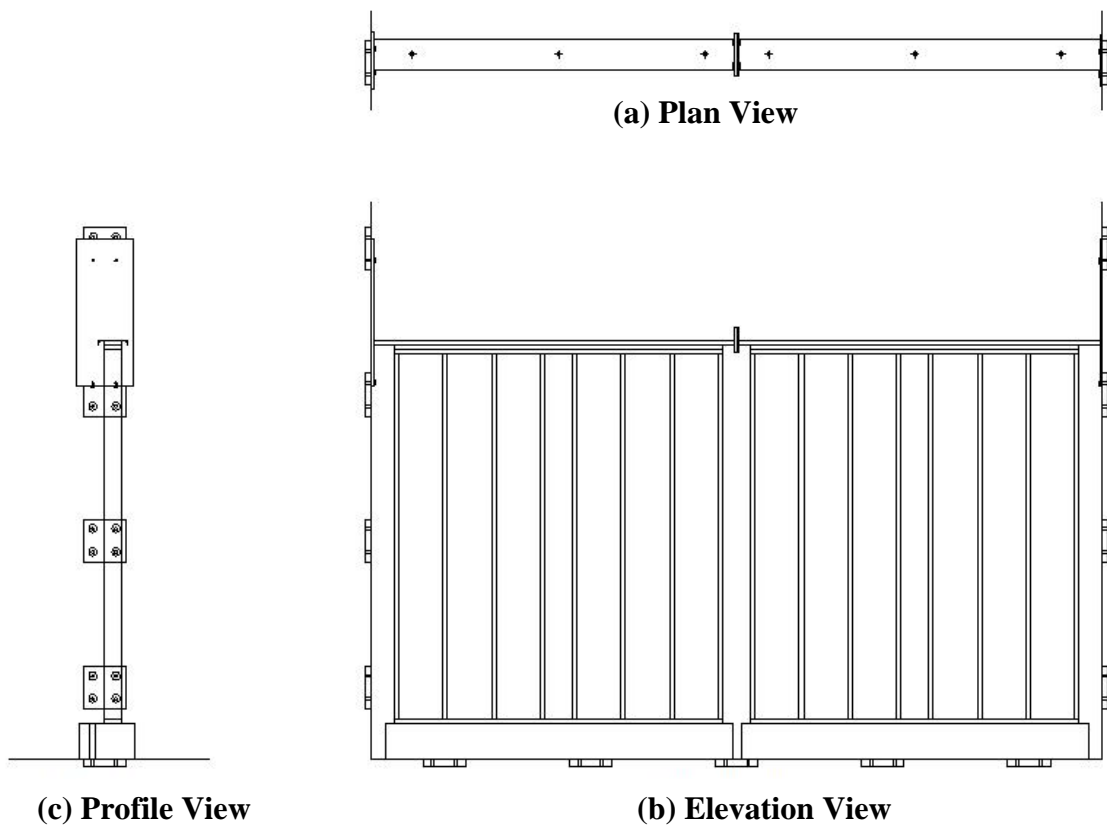
Figure 3.1: Test Assembly Schematic

3.3.2. Test Assembly: There were three major components to the assembly, as shown in Figs. 3.1-3.3: a simulated concrete foundation, top steel cross-beam support, and the wall or roof test specimen. Two concrete foundation blocks were bolted to the strong floor at the UF structures laboratory. Each foundation block had a dimension of 1 ft x 1 1/2 ft x 9 1/2 ft. Prior to casting, the concrete forms were fitted with PVC pipe passing completely through the formwork, reinforcing bars, and J-bolts. The foundation blocks were secured to the floor using threaded rod once they were sufficiently cured. Each foundation block was placed with the rod passing through the PVC pipe in the concrete. A nut was placed on each rod and tightened sufficiently to secure the block to the laboratory floor. Each foundation block had six J-bolts extending 6 in. out of the top of the concrete to secure the base of each test specimen. The exposed ends of these bolts were used to secure the bottom of each specimen in place, simulating the method used to secure a stud wall to its foundation. Each steel beam consisted of a 3/4 in. plate on each end of an MC 10x8.4 channel. The larger plate was bolted to each side of the strong wall using 5/8 in. A325 structural bolts, while the smaller plate was used to connect the two beams at midspan. This provided lateral stability for the header of each specimen. The specimens were attached using 1/2 in. bolts through the channel and specimen header.

Erection of the specimen was accomplished by first placing the specimen over the embedded J-bolts and attaching with a washer and nut. A steel bracket was used to temporarily support the specimen prior to the cross-beam placement. The bracket was attached and removed from the strong wall to allow finishing of the “interior” portion of the specimen after erection was complete. A clamp was used to secure the specimen to the bracket. Finally, the channels were lifted into place and secured at all appropriate locations.

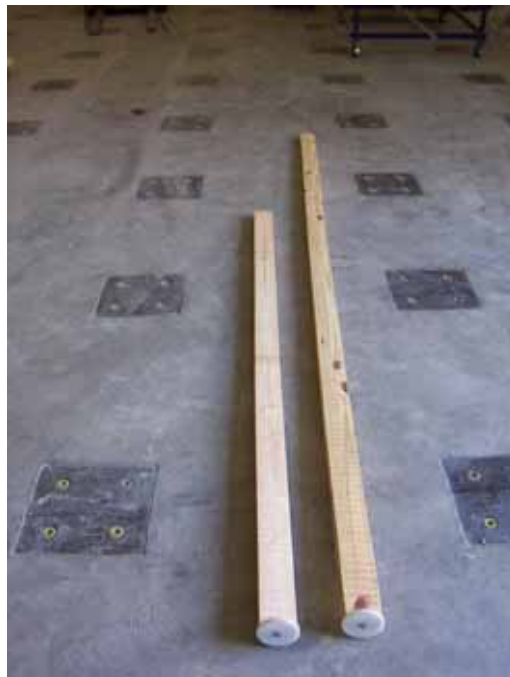
Figure 3.4: A 9 lb and a 15 lb Missile

3.3.3. Missile: Each missile was constructed using surface dry Southern Pine 2x4 in. boards. Figure 3.4 shows a typical basic 9 lb and an enhanced-A5 lb missile. The missiles were sized such that the weight was between 9 and 9 1/2 lb with a length between 7 and 9 ft. or with a weight between 15 and 15 1/2 lb. and a length between 11 and 13 ft. in accordance with FEMA-361 (2002). Missiles were chosen such that no knots appeared within 12 in. of the leading edge. The trailing edge of each missile was affixed with a plastic sabot to facilitate launching. This connection was accomplished by using a 3 in. long, 5/8 in. diameter screw. The sabot's weight did not exceed 1/2 lb.

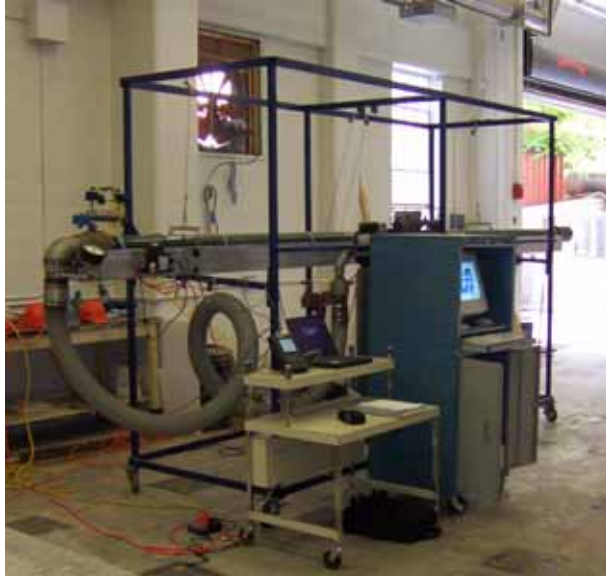
Figure 3.5: Large Missile Cannon at UF

Figures 3.5 through 3.7 display the large missile cannon at UF. A steel tube frame mounted on casters supported the entire mechanism, allowing mobility of the apparatus. The cannon barrel rested on an aluminum beam, which was hung from steel

cables supported by the frame. These cables could be adjusted using a pair of winches, thereby adjusting the height of the cannon barrel. Two air compressors were mounted onto the frame. The larger of the two compressors provided the air pressure required to facilitate launching, while the smaller one powered the trigger release mechanism. The firing mechanism is shown in Figure 3.8. Once the desired launching pressure was attained, pushing the trigger activated a piston, powered by the small air compressor, which opened the release valve. With this setup, it was assured that the release valve was opened rapidly and with consistency. The cannon barrel was approximately 20 ft. long with a stopping bolt located near the firing controls. The stop assured that each missile was fired from a consistent location in the barrel.

3.3.4. Large Missile Cannon: The large missile cannon at UF used compressed air to propel a large missile at the test specimen at standard testing speeds in accordance with FBC (2001) TAS 201-94 Impact Test Procedures and DOE Standard 1020 (1994). The basic and enhanced-A large missile impact tests required a 9 lb. and a 15 lb. missile to be fired at 50 ft/sec. (34 mph) and 73 ft/sec (50 mph), respectively. Several major components comprised the missile cannon including the following:

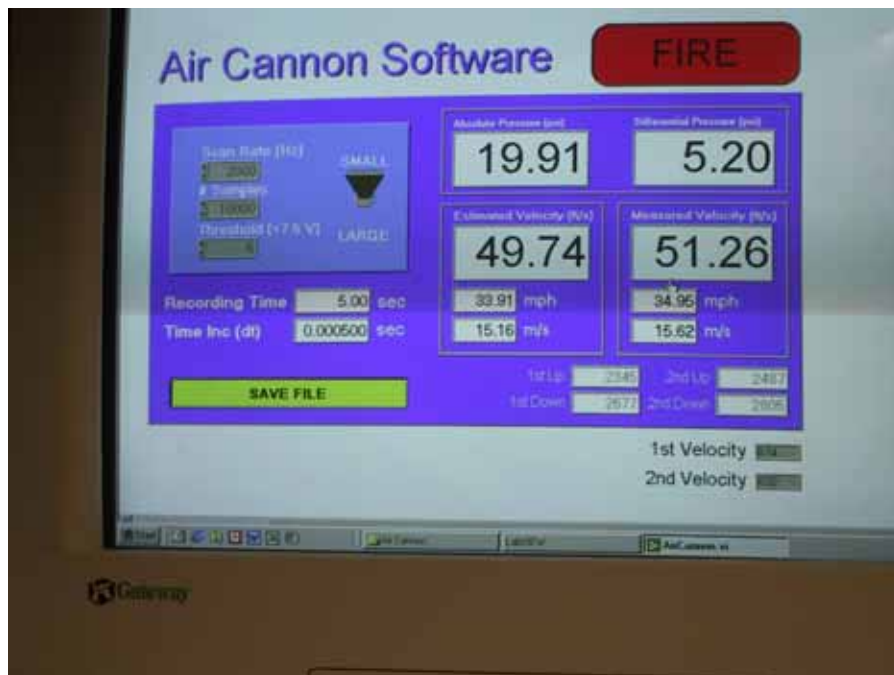
Figure 3.8: Labview Data Acquisition System

3.3.5. Measurement and Data Acquisition System: The large missile cannon timing system comprised of two photoelectric sensors, a data collection computer running Labview, shown in Figure 3.8, handwritten data collection sheets, shown in Figure 3.9, and an optional oscilloscope. This timing system was capable of measuring speeds accurate to $\pm 2\%$. The speed of the missile was measured anywhere between the points where 90% of the missile was outside of the cannon and where the missile was 1 ft. away from the test specimen. The speed was not measured while the missile was accelerating.

The timing system on the cannon at UF had the photoelectric sensors attached near the end of the cannon. The sensors, located 3.28 ft apart, were triggered as the missile passed. Using the photoelectric sensors, in addition to a pressure transducer, the computer recorded the gage and absolute pressure in the cannon, and trigger times for both photoelectric sensors, which was then used to calculate the exit velocity of the missile. As the firing pressure in the cannon was

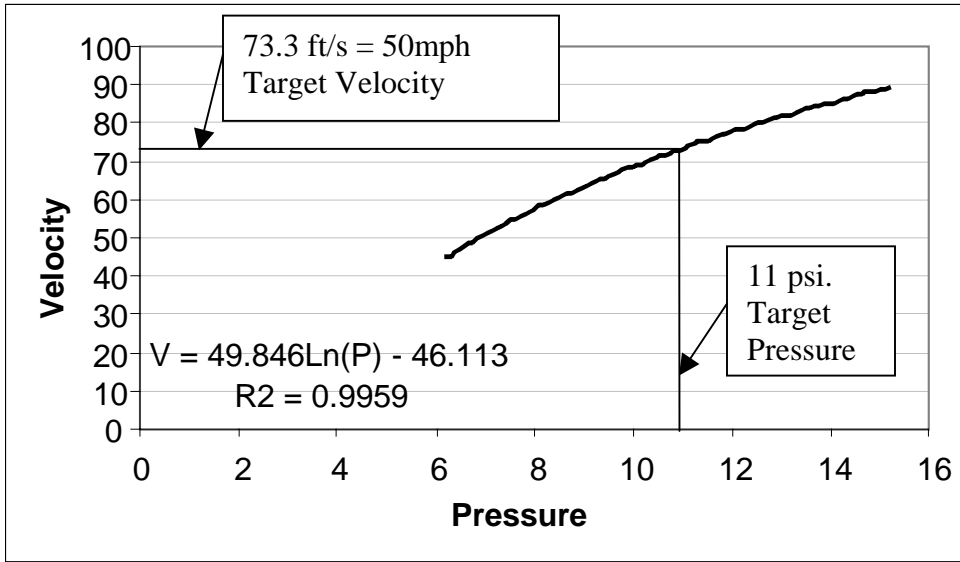
Figure 3.10: Large Missile Calibration Curve

charged, Labview calculated the estimated missile velocity. This calculation was made using equations developed during the calibration process. During calibration, each size missile was fired using a range of pressures. The measured velocity and pressure were recorded for each firing and entered into an Excel spreadsheet. These values were plotted for each missile and a logarithmic curve was fitted to each plot, as shown in Fig. 3.10. The generated equations for both missiles are as follows:

$$9 \text{ lb. Missile } \quad V = 58.51 \ln(p) - 46.724 \quad (3.1)$$

$$15 \text{ lb. Missile } \quad V = 49.846 \ln(p) - 46.113 \quad (3.2)$$

where p is the gage pressure in psi and V is in ft/sec.

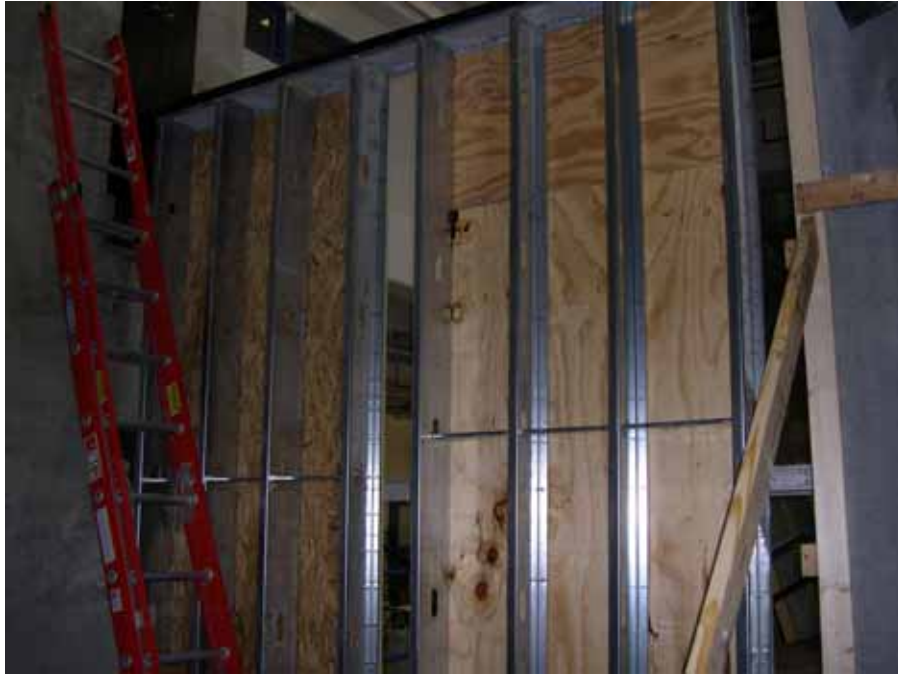
Figure 3.16: Steel Stud Wall Specimen

3.7.2. Metal Stud Framing System: For the steel framed specimens, 8 in. 16 ga. C-shaped channels were used as studs, as shown in Fig. 3.16. The studs were attached and bridging was added between the studs using self-tapping screws. The plywood and OSB coverings were attached using self-tapping drywall screws. The 5V Galvalume panel alignment and fastener pattern was determined using the manufacturer's installation manual. The panels were fastened using #14 x 7/8 in. screws, 24 in. o.c. to 1/2 in. plywood covered with 30 lb. felt.

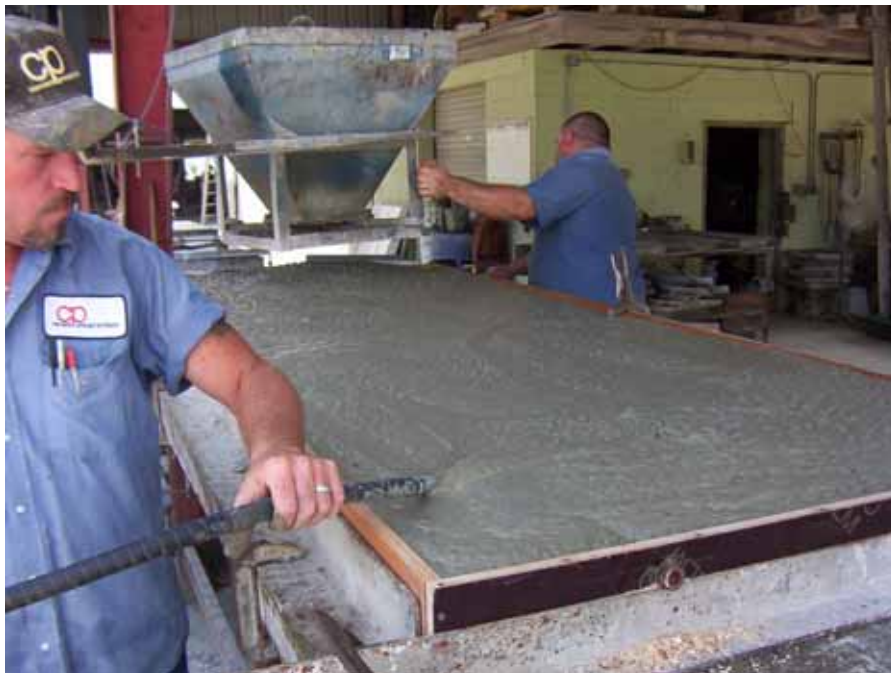
Figure 3.17: Construction of the Tilt-up Panel

3.7.3. Concrete Panels: The concrete and masonry specimens were constructed in place, with the exception of the tilt-up and hollow core specimens. The tilt-up panel, as shown in Fig. 3.17, was constructed in a precast yard and transported to the laboratory. PVC pipes were embedded in the panel to allow it to rest on the foundation block over the top of the j-bolts. Lifting devices were embedded into the top of the tilt-up walls to allow lifting and placement with the laboratory crane. The tilt-up specimen was supported using the shoring system described earlier in this chapter. At the time of construction, two 4x8 in. cylinders were cast. These cylinders were tested to determine the concrete's 28-day compressive strength, which was found to be 4150 psi. The hollow core slabs were placed on the foundation block with the j-bolts falling in the cells. Two holes were drilled in each of the slabs through which threaded rod was placed to secure lifting hooks. Again, the slabs were lifted and placed using the laboratory crane.

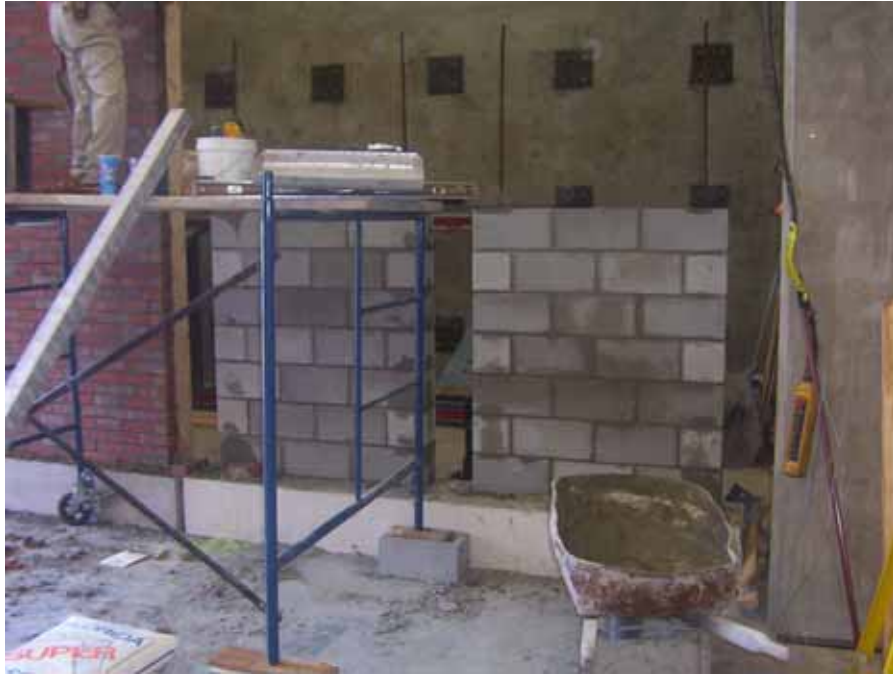
Figure 3.18: Construction of CMU Specimen

The CMU specimens were constructed in place. No. 6 reinforcing bars were epoxied into the foundation block and allowed to extend out approximately 36 in. These bars were

located such that they would fall in the end cells of each CMU specimen as seen in Fig. 3.18. These end cells were grouted as a safety precaution. One of the two CMU specimens had horizontal truss type reinforcement in it.

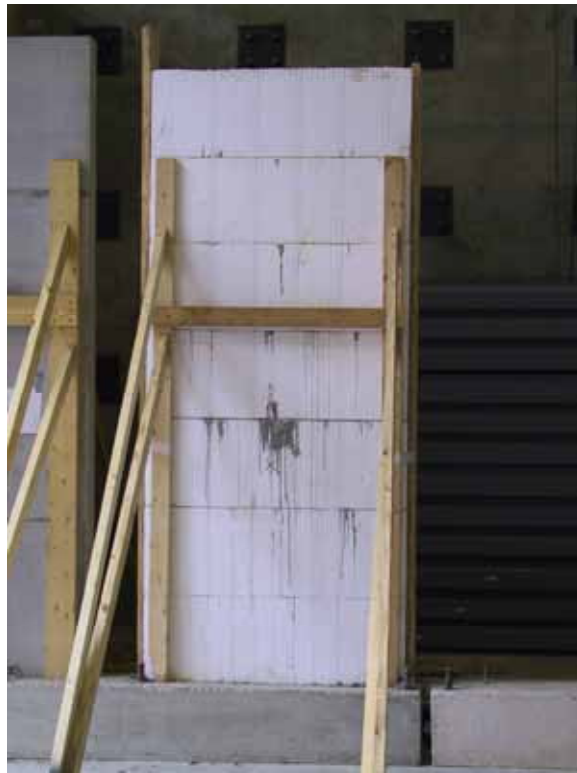
Figure 3.19: Completed ICF Specimen

The ICF wall specimen, shown in Fig. 3.19, was constructed in-house. Four #6 reinforcing bars were epoxied into the foundation blocks. The forms were placed over these bars with #3 bars as horizontal reinforcing. The bars and forms were secured together using wire ties to protect against separation during the concrete pour. The open ends of the forms were closed off by attaching 2x10 in. timber studs initially using nylon reinforced tape. Once the first lift of concrete had been poured, ratcheting straps were added to the forms to prevent the concrete from dislodging the studs. The concrete for the specimen was mixed in the laboratory mixer. Each batch provided a 1 ft. lift. Lifts were placed in pairs, and then allowed to cure for 1 hour before the next set of lifts were placed. This procedure was followed in order to prevent failure of the forms due to the hydrostatic pressure exerted by the concrete. Eight cylinders were cast at the same time and allowed to cure for 28 days at which time they were tested. They were allowed to cure in the same conditions as the test specimen. Three of the cylinders were tested and the 28-day compressive strength was found to be 7250 psi.

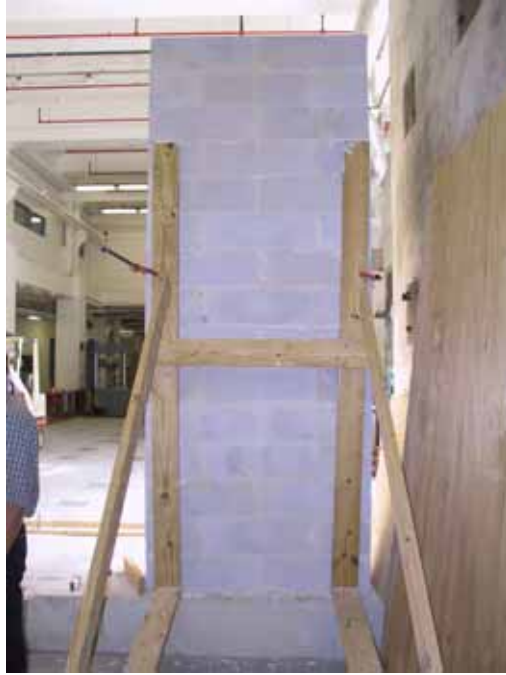
Figure 3.20: Completed AAC Specimen

The AAC specimen was constructed by Painter Masonry on the concrete foundation block, as shown in Fig. 3.20. The AAC blocks measured 8x8x24 in. and were secured using thin-set mortar. No reinforcement was included in the specimen based on common building practices. The blocks were cored to fit over the J-bolts in the foundation block. The

constructed specimen was supported using the same shoring system as the other concrete specimens.

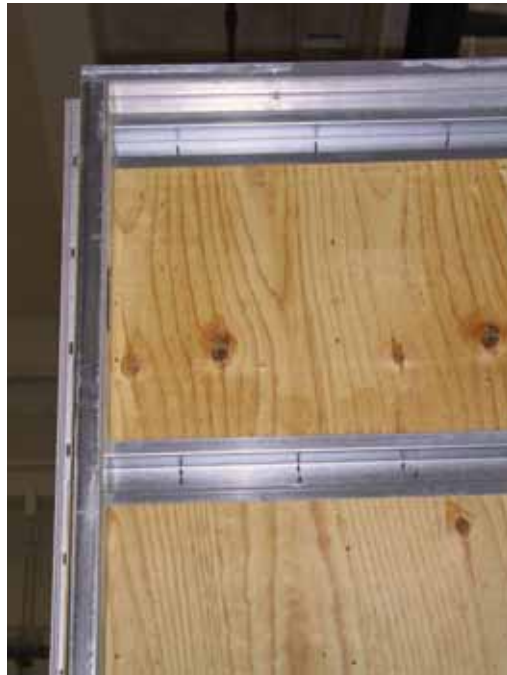
Figure 3.21: Plywood Attached to Purlins

3.7.4. Roof Truss Systems: The roof truss systems were constructed using a frame consisting of 3-5/8 in. cold-formed steel studs at 48 in. o.c., simulating the top truss chord, and 16 ga. 1-1/2 in. hat channel purlins at 24 in. o.c. The exterior cladding was secured to the purlin system, as seen in Fig. 3.21. Fifteen pound felt was used over the top of the plywood and OSB cladding. The 5V Galvalume panels were fastened in the same way as in the steel wall frame specimen.
