Gable End Walls

Your house has a gable end if it has a triangular wall that sits on a rectangular wall. If so, the gable end walls of your home can take a tremendous beating during a hurricane. If not properly braced and anchored, it can collapse and you will have a catastrophic amount of damage to your home. However, of all the possible structural retrofits, gable end walls are usually the easiest to strengthen and deserve to be a high priority on your retrofit list. Basically there are three things to be concerned about with gable end walls. First, the most common type of

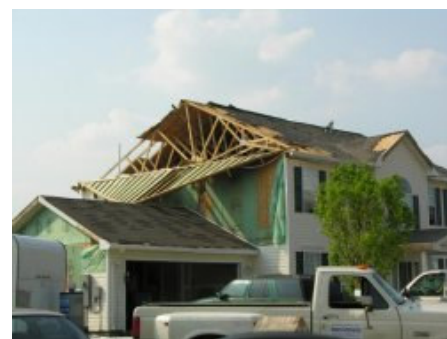
The most common gable end failure is one where the wall loses support along its top edge and is folded outward

failure is loss of roof sheathing from the gable end that results in the gable wall losing its bracing along the top edge. The second most common type of gable end failure is at the connection between the rectangular and triangular walls. The third potential weak link is the actual framing members that make up the gable end wall structure. In many houses, these members are simply the structural members of the last roof truss. Consequently, they are 2x4 lumber members that end up being bent by pressures applied to the wide flat part of the 2x4s – the direction in which they are the thinnest and therefore weakest. In homes with rafters and ceiling joists, the wall structure will typically be made of 2x4s turned so that wind forces are applied to the narrow face of the 2x4s (the orientation with the strongest resistance to bending of the 2x4s) but they may only be just toe-nailed to the rafters and ceiling joist.

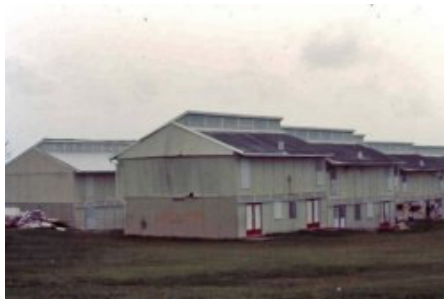
An example of the second most common type of gable end failure - the connection between the rectangular and triangular walls – It is rare that you actually find one that looks like this because usually the wall below fails and the whole end collapses.

In the photo above on the left, notice that wind has caused the gable end triangle to be partially pulled off the rectangular wall below. A little more wind would likely have caused the whole gable end to come off the building thereby exposing it to a lot more wind damage and certainly water damage.

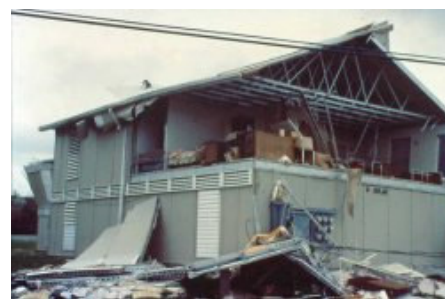
This is the more common look of a gable end failure when the triangular wall and rectangular wall separate

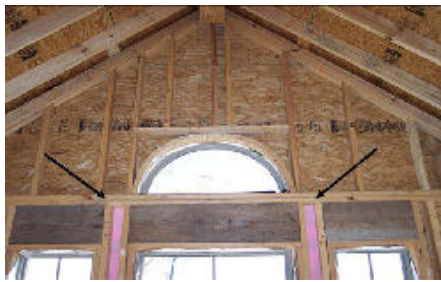
Gable end wall with cathedral ceiling - note the horizontal joint running across the wall just below the semicircular window. The arrows point to where this wall is apt to fail in strong winds. Because there are no continuous vertical members crossing the indicated line, that line becomes a hinge point where the wall is likely to buckle.

Gable end walls on rooms with vaulted or cathedral ceilings, while common (particularly when facing the coast or water), pose special problems for retrofitting. Unless special care was taken in the design and construction of these walls to provide the kind of bracing they need to stand up to strong winds, they are very likely to fail. The structural solutions usually involve beams that either span across the width of the wall or columns that span from floor to ceiling. In many cases, when the wall was originally constructed, the builder could have used continuous members that run from the floor to the ceiling and avoided the weakness. If you have one of these walls, you probably can push on the wall and see it deflect (move). If so, you need to hire a structural engineer to develop a good structural solution for your particular situation.

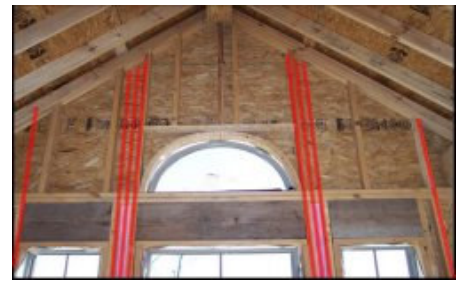
The red lines indicate where continuous wall framing members could have been used by the builder to avoid the weak connection between the rectangular wall at the bottom and the triangular wall at the top. A large continuous horizontal beam (probably a glue laminated beam) that is well anchored to the side walls would be an alternate solution.
