# GENERATOR SHELTER IMPACT TEST REPORT (.08 Material)

May 2007 – Revised October 2007

Per the request of the Division of Emergency Management and the Department of Community Affairs, Barkley Consulting Engineers, Inc. supervised a modified large missile impact test on generator enclosures (.08 material). The purpose of the test was to determine if the JRS Custom Fabrications, Inc. supplied enclosures would meet the modified (see modification section, page 4) large missile impact test. The tests were conducted at JRS Custom Fabrications, Inc., 168 NW 68th Avenue, Ocala, FL on May 16th & 17th 2007. This summary only discusses the .08 material.

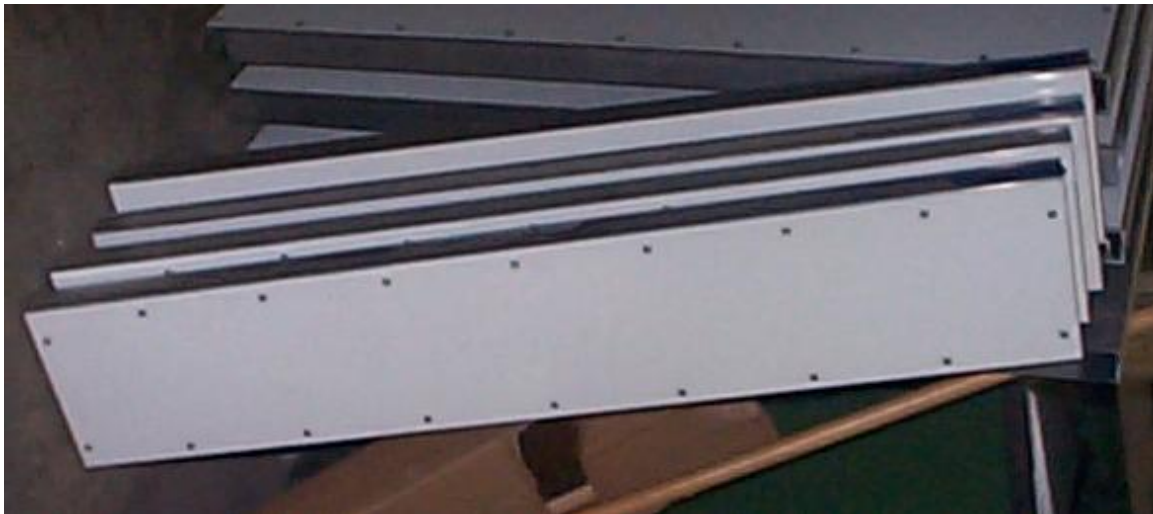
The testing process began with assembling the various panels that were to be tested, as shown in the following figure.

**Figure 3.** 4'-0" x 0'-7" Test Panel Assembled for Testing
