## Masonry Walls

Modern reinforced masonry wall houses have been found to perform quite well in hurricanes. In contrast, un-reinforced masonry houses (those without enough reinforcing steel) have not performed well and they can be dangerous because they tend to fail suddenly and catastrophically. Concrete is very strong in compression but very weak in tension. Consequently, without steel reinforcing to provide tension resistance, it is quite brittle as can be seen by cracks in driveways and sidewalks. Masonry houses make use of both the reinforcing steel and their roof diaphragms to preserve their structural integrity. Keeping the roof intact is very important for all houses, both because it keeps the wind and rain out and because it provides critical support for the top of the walls. Masonry walls that are not braced at the top are notorious for blowing over in strong winds. To make the wall more resistant to bending and to provide greater uplift resistance vertical reinforcing is added to the walls. This may start with a relatively short piece or reinforcing steel that is cast or grouted into the foundations and lines up with one of the hollow cells in the concrete block to be i

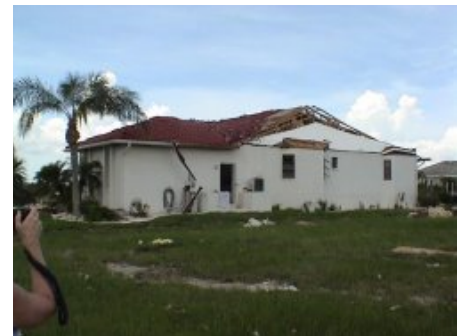
**When the roof sheathing on the gable end was torn off, the top of the gable end wall was left un-supported and broke over above the bond beam.**

To strengthen or bond together the tops of walls steel is placed horizontally in the top row of special "U" shaped concrete blocks and the vertical steel is bent over so that it forms a good connection with the horizontal steel. Again concrete or grout is poured into that top layer of block. This structure is called a bond beam. When

engineers want to create very strong beams at the tops of walls they will use form work to create a mold for the concrete at the top of the wall. They will place several pieces of steel reinforcing in a grid and pour the form full of concrete. This creates a very strong beam called a tie beam at the top of the wall. These types of tie beams are used extensively in Miami-Dade and Broward Counties.
